Hot Corrosion of Single-Crystal NiAl-X Alloys

James A. Nesbitt
Lewis Research Center, Cleveland, Ohio

National Aeronautics and
Space Administration

May 1998

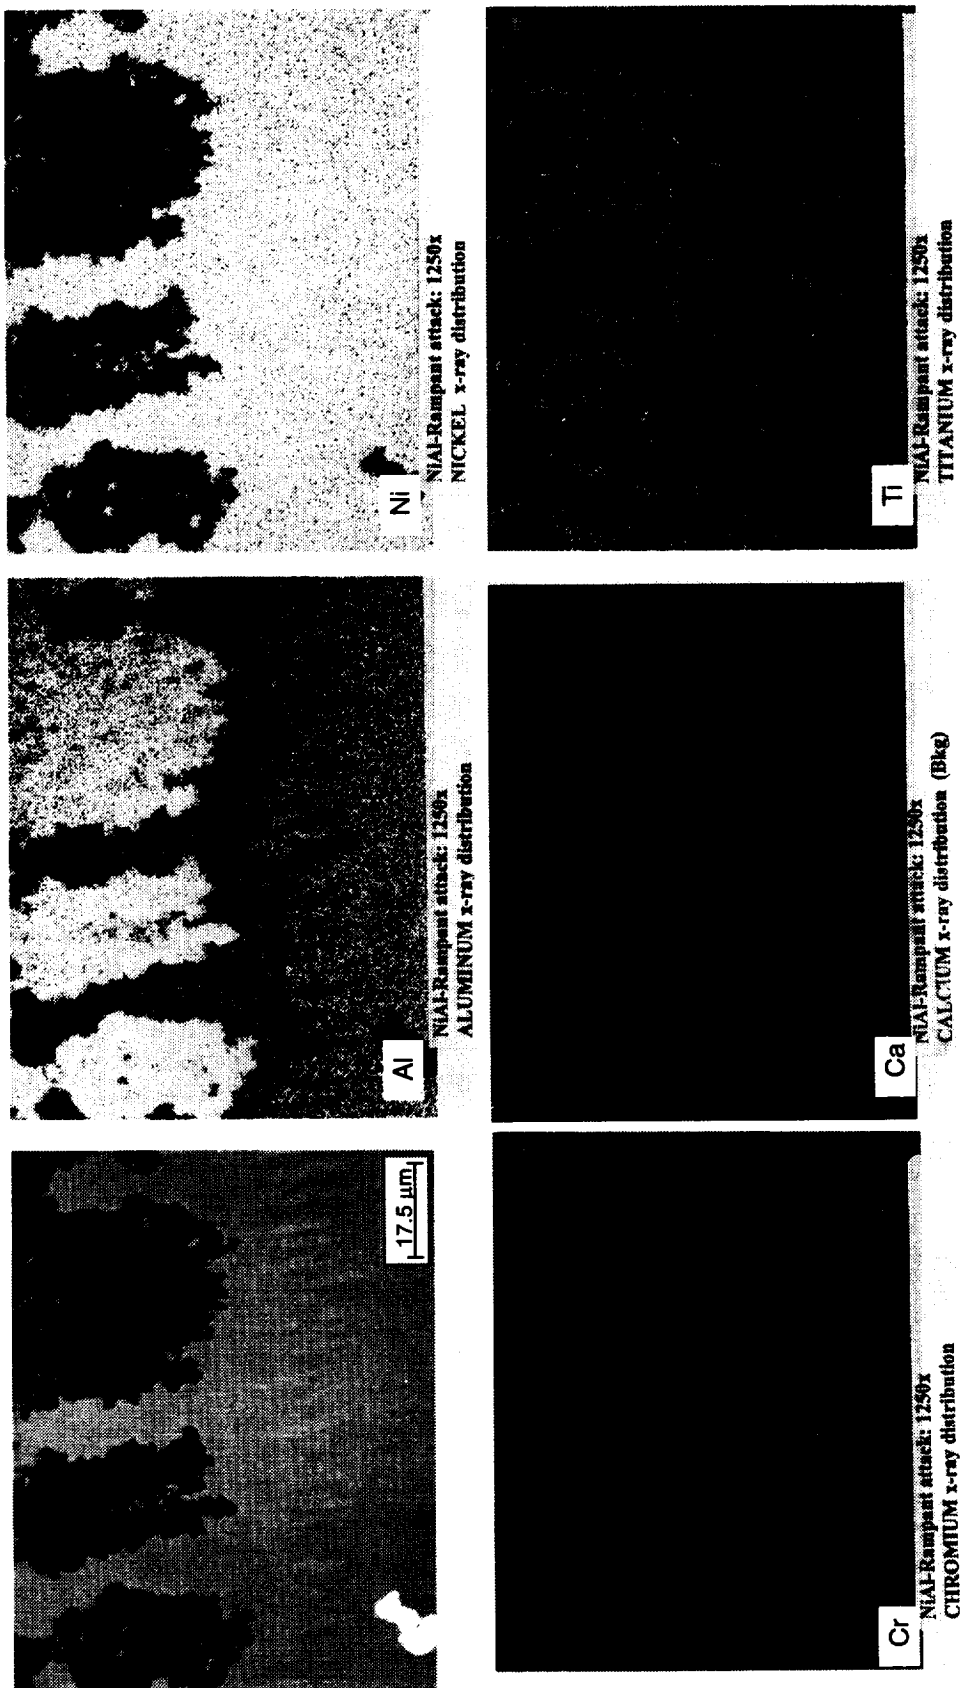
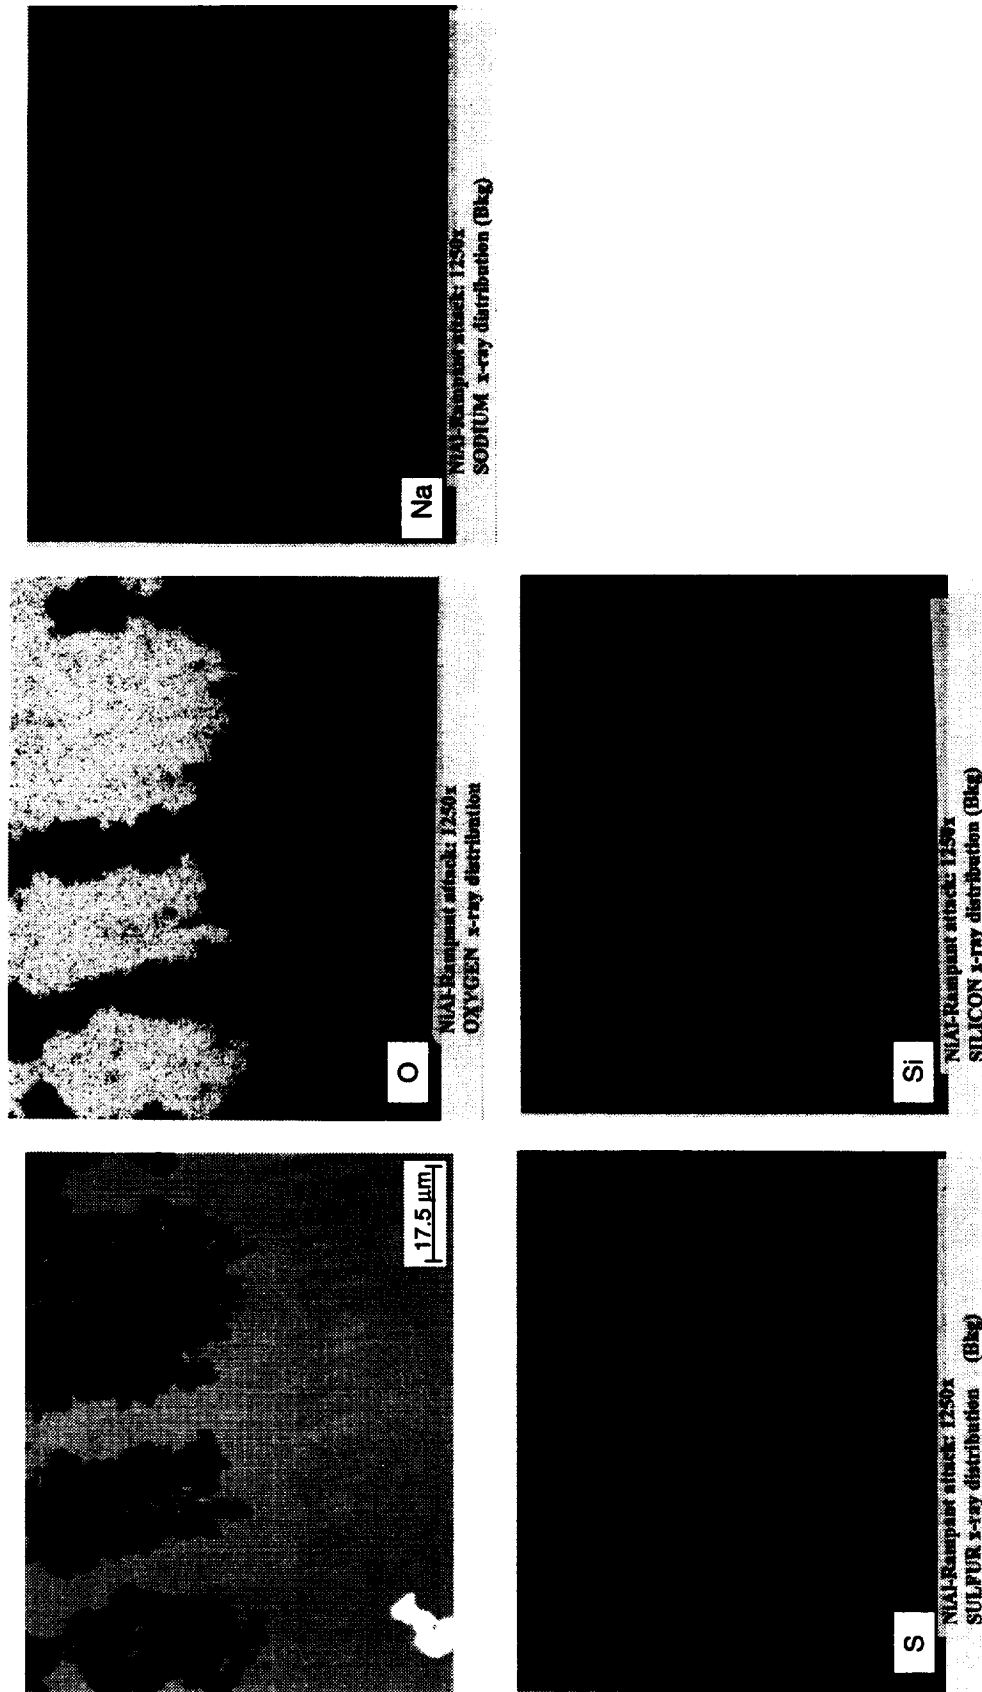
striations are also evident in much of the oxide in this figure. Elemental distributions in the region of Fig 101d is shown in the x-ray maps in Fig 102. The striated oxide is primarily Al and Ti with a small presence of Cr. Regions of γ and γ' can be distinguished from the Al map. Not surprising, the Ti partitions to the feathery γ' below the oxide phase. It is significant that there appears to be no enrichment of Ca, Si or Na in the x-ray maps of Fig 102.

Fig. 102 X-ray map of inner region of rampant attack shown in Fig. 101d (AFN19 after 300 hrs).

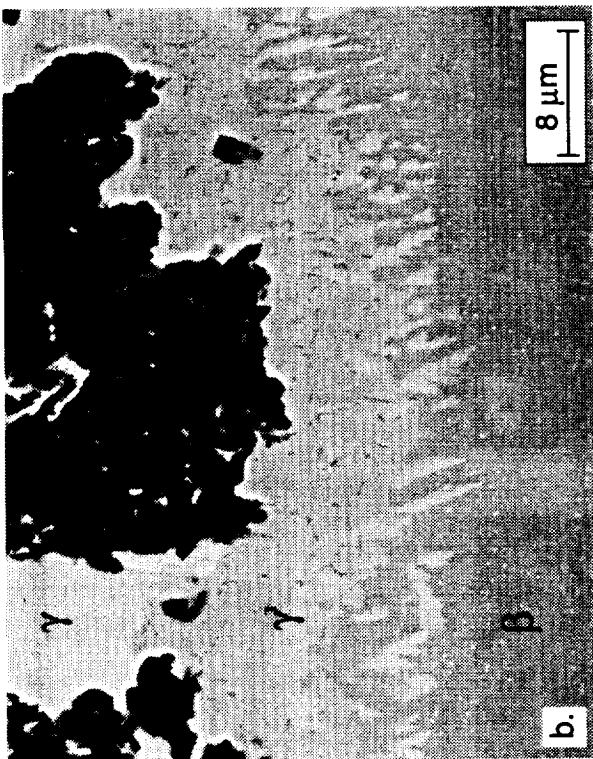
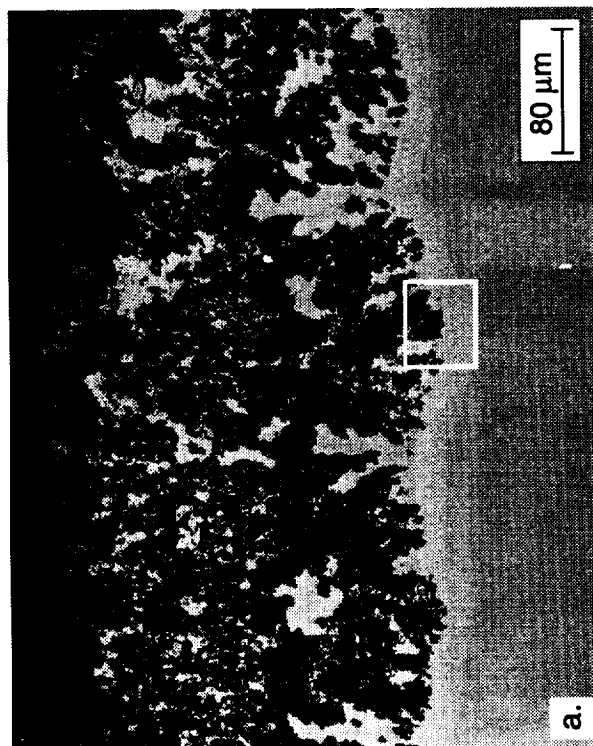
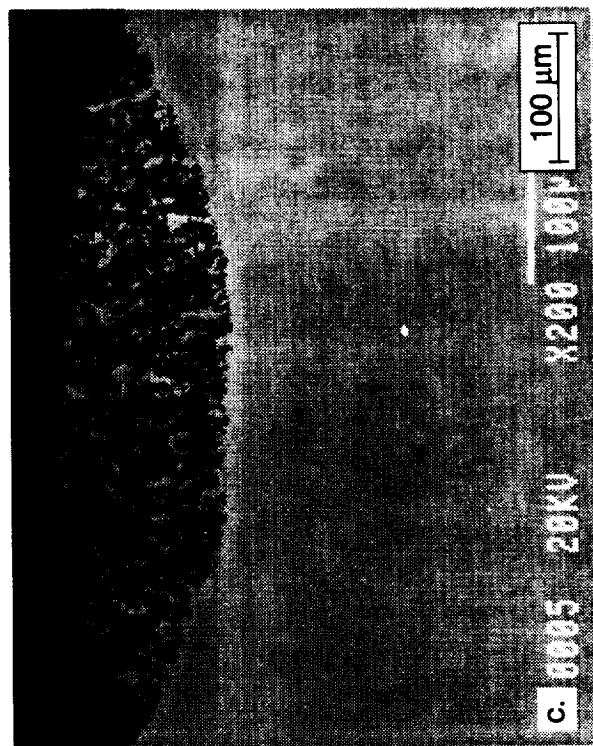
Regions of rampant attack on D219 and AFN20, which exhibited poor overall corrosion behavior, are shown in Fig 103. The magnified view of the inner region of attack in (b) shows the γ and γ' phases. The lighter and darker oxide in this image has a mottled appearance rather than the striated appearance of that in Fig 101d. Elemental distributions in an attacked region of AFN20 are shown in the x-ray maps in Fig 104. Again, most of the oxide is Al-rich (Al_2O_3) with lower concentrations of Ti. A close examination of the Ni and O maps show that many of the Ni islands in the attacked region are metallic with smaller NiO islands in the outer portion of the attacked region. Ca and Cr appear enriched only on the surface. The higher magnification maps of the inner attacked region shown in Fig 105 clearly show the depletion of Al and the association of Ti and Al in the oxide. The concentration profile in this figure clearly shows an Al gradient in the β phase indicating Al transport towards the oxide. There is also a small Ti gradient in the β phase which indicates Ti transport towards the γ' phase and oxide. There are no apparent compositional differences in the inner region of rampant attack between the AFN19 (Fig 102) and AFN20 (Figs 104,105) although the overall corrosion behavior of the alloys was significantly different. Figure 106 shows regions in AFN19 which appear to be in transition from intermediate to rampant attack. Oxide fingers are penetrating into the alloy, however isolated γ' precipitates are still present below the oxide fingers. Some of the oxide shows the dark and light striations whereas other regions appear mottled.

Fig. 103 Regions of rampant attack on (a,b) D219 and (c) AFN20. Image (b) is a higher magnification of the box in (a).

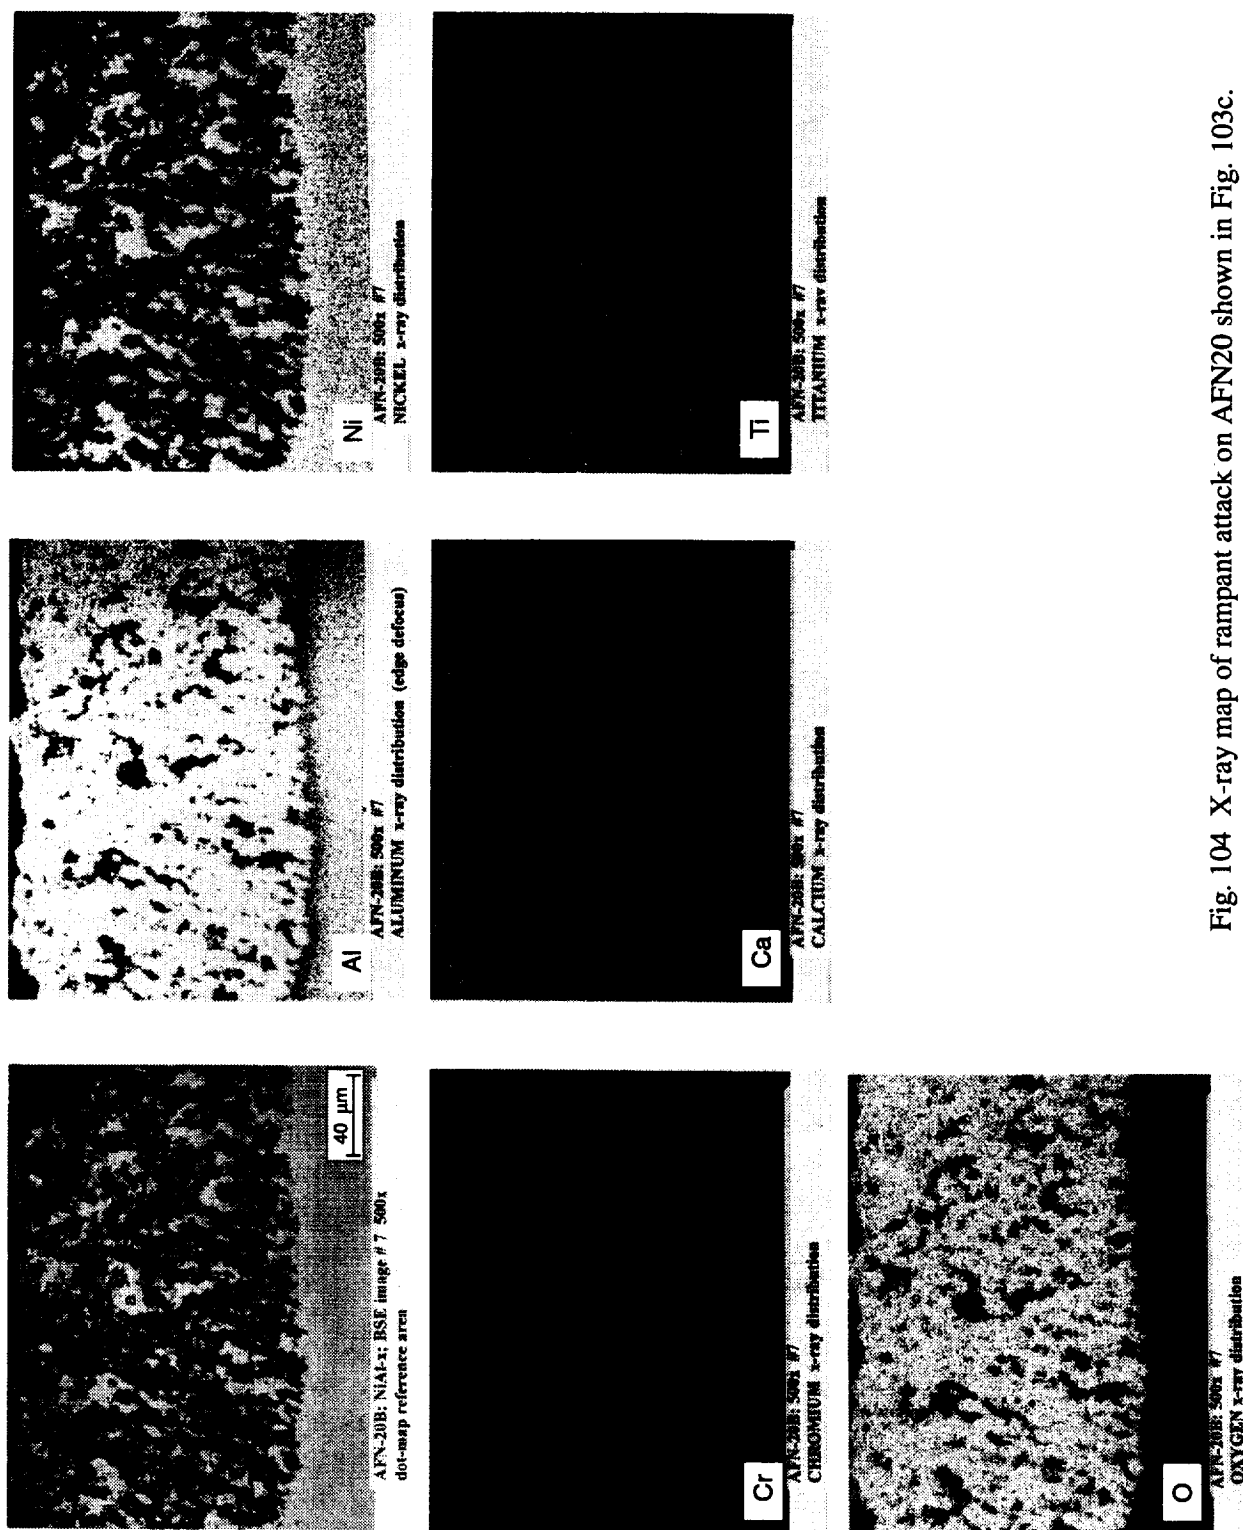
Fig. 104 X-ray map of rampant attack on AFN20 shown in Fig. 103c.

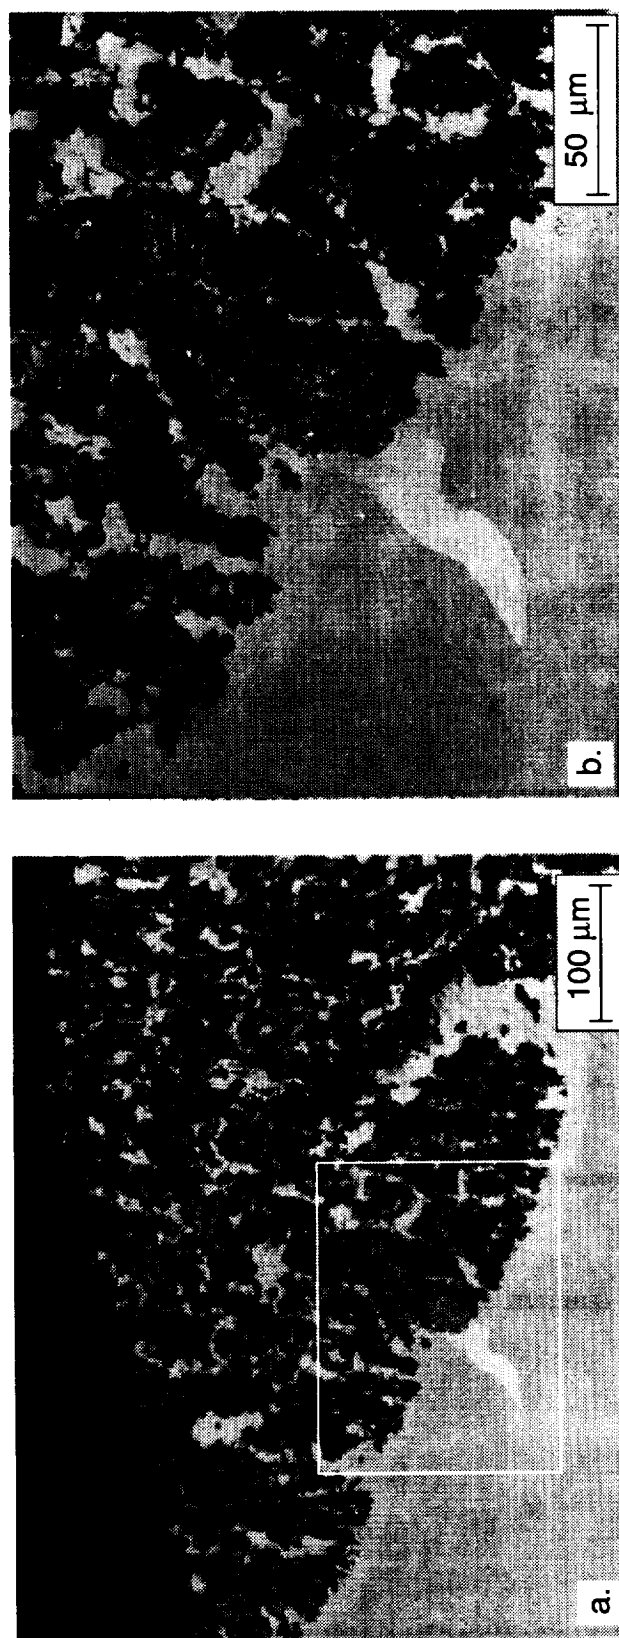
Fig. 106 Regions undergoing transition from intermediate to rampant attack in AFN19.

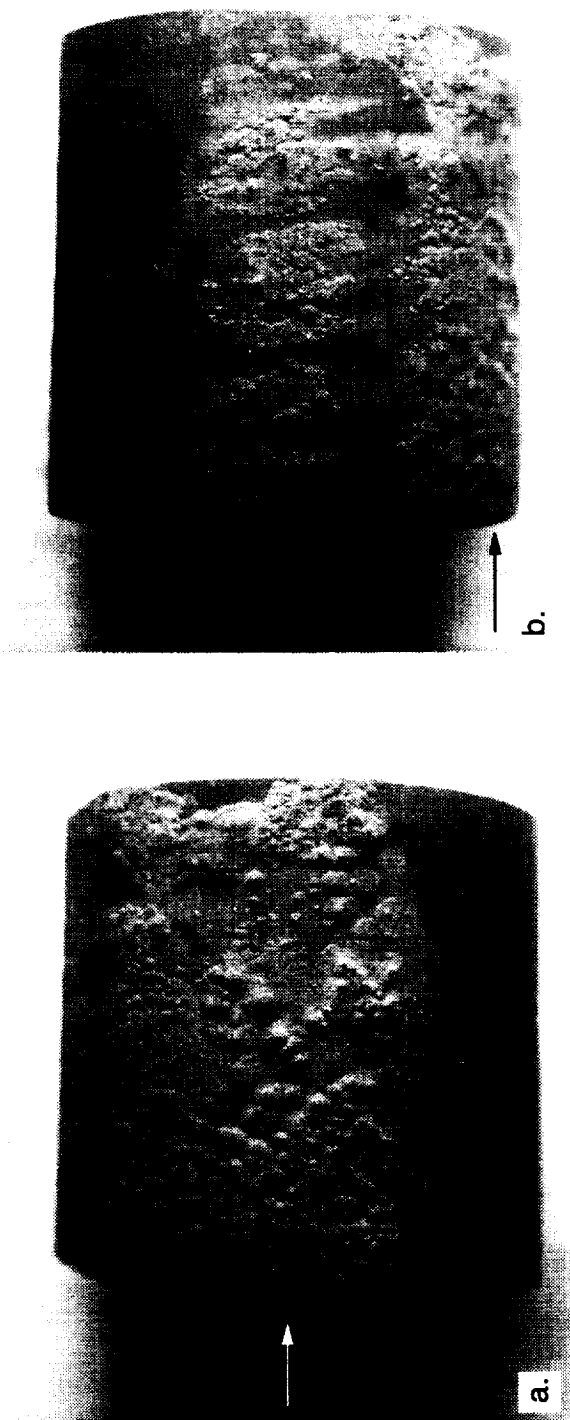
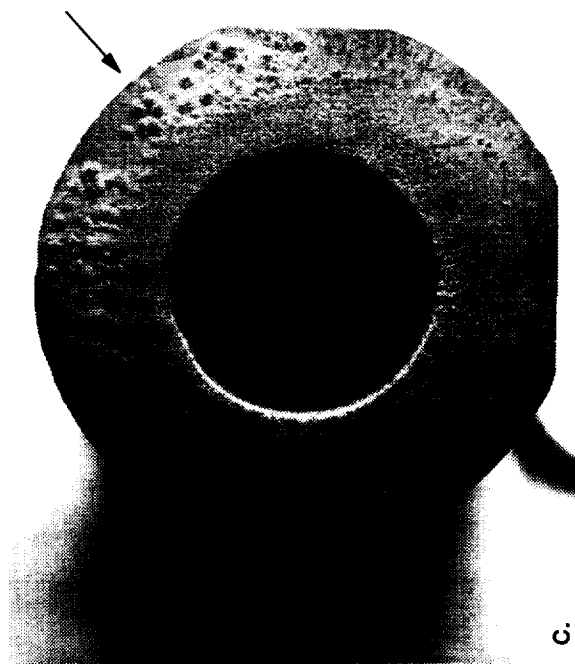
The surface morphology of the samples after 63 hrs, the last time samples were photographed after the same test exposure, are shown in Figs 2-5. Non-uniform accelerated attack on two regions on the curved surface of AFN19 is shown in Fig 2a,b. The attacked region in Fig 2a is curved whereas the attacked region shown in Fig 2b is flat. It appears that some of the accelerated attack on the flat region follows some of the dendritic pattern discernible on the surface. The arrows in Fig 2a,b indicate the attacked curved surface shown in Fig 2c. The mounds on the end are located on the same portion of the sample with the accelerated attack on the curved surface. Typical corrosion mounds are shown on the ends and curved surfaces of AFN21 and AFN22 in Fig 3. Elongated corrosion mounds on the end of AFN21 (lower portion of Fig 3b) appear to be following small ridges remaining on the sample from the EDM cutting. Very little attack was observed on the AFN23 sample (Fig 4a,b). The AFN24 sample showed more attack on one half of the curved surface (Fig 4c). Both the AFN25 and AFN26 samples show some small mound formation on the surface. The AFN25 sample has two regions on the end where mechanical test samples were removed from the ingot. Neither region shows any indication of accelerated attack.

Appendix B Fig 2 Macrophotos of electropolished AFN19 after 63 hrs (a,b) two views of curved surface, (c) end to the right in (a,b). Arrow in (c) indicates the attacked curved surface shown by arrows in (a,b).

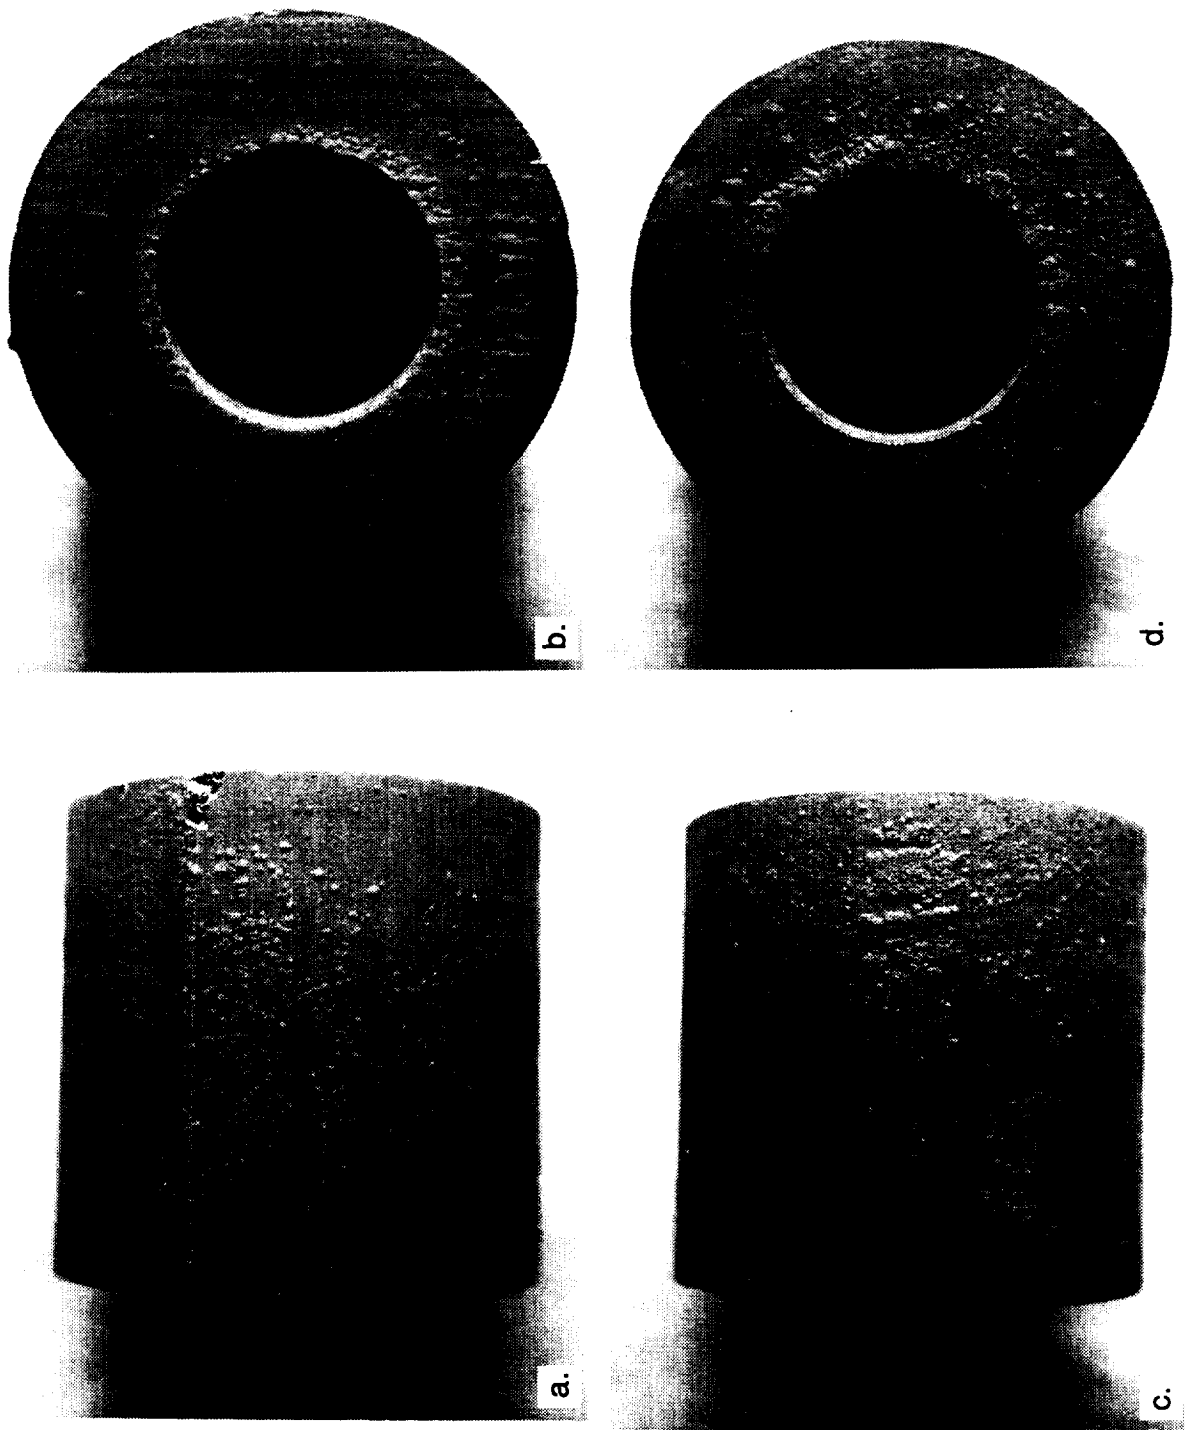
Appendix B Fig 3 Macrophotos of electropolished (a,b) AFN21, (c,d) AFN22 after 63 hrs.

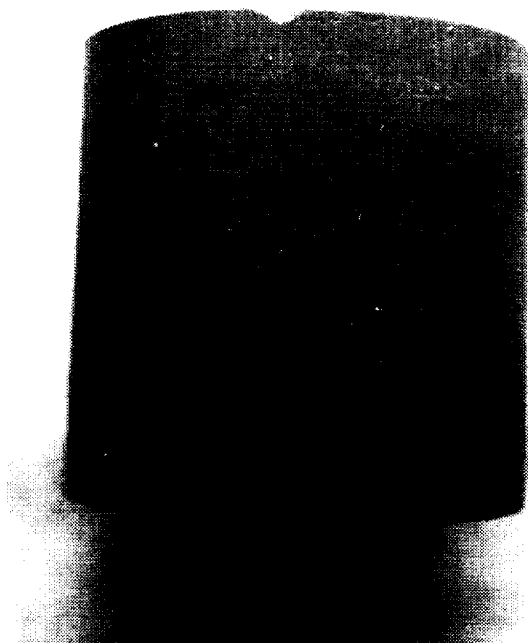
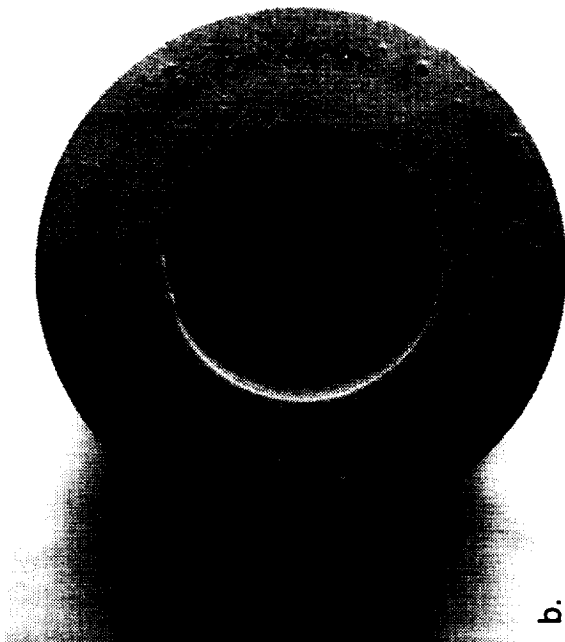
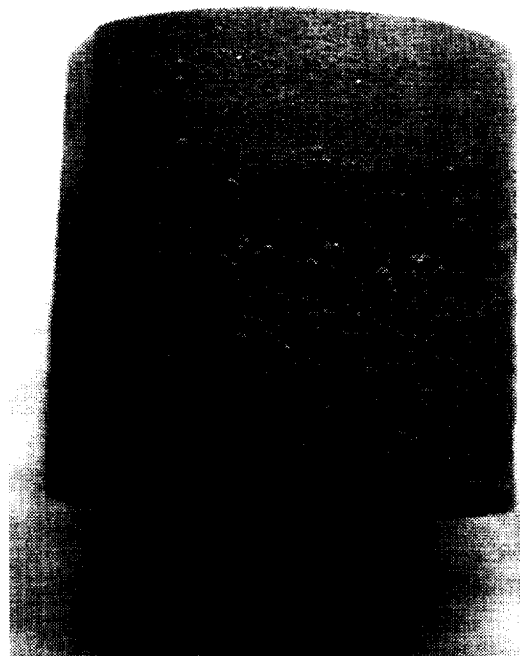
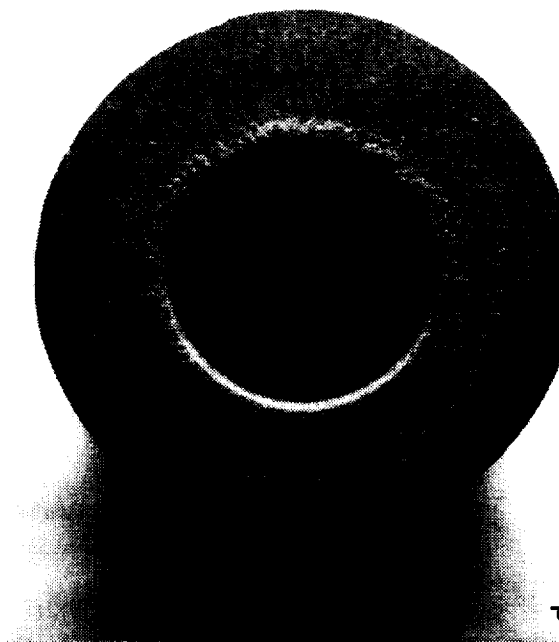
Appendix B Fig 4 Macrophotos of electropolished (a,b) AFN23, (c,d) AFN24 after 63 hrs.

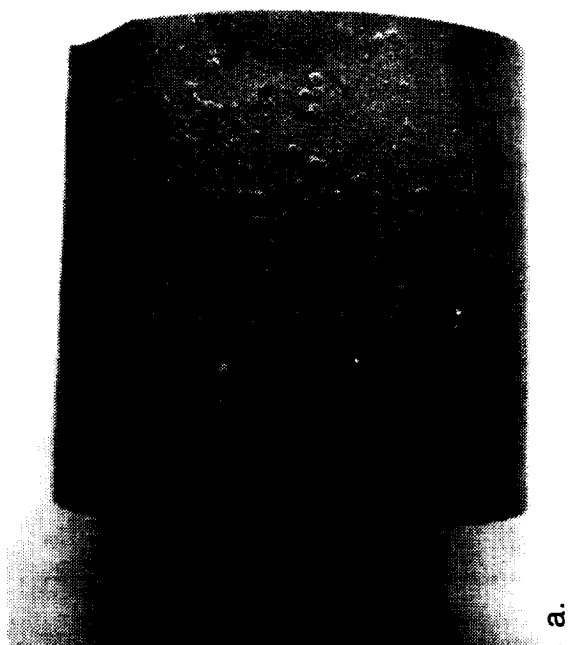
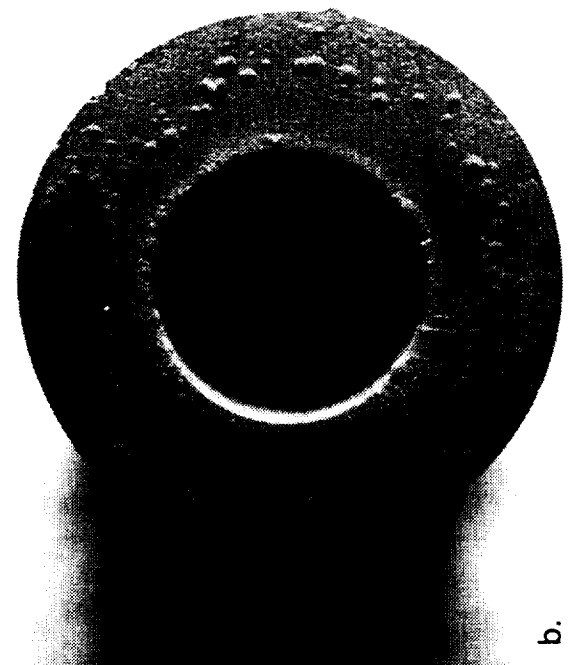
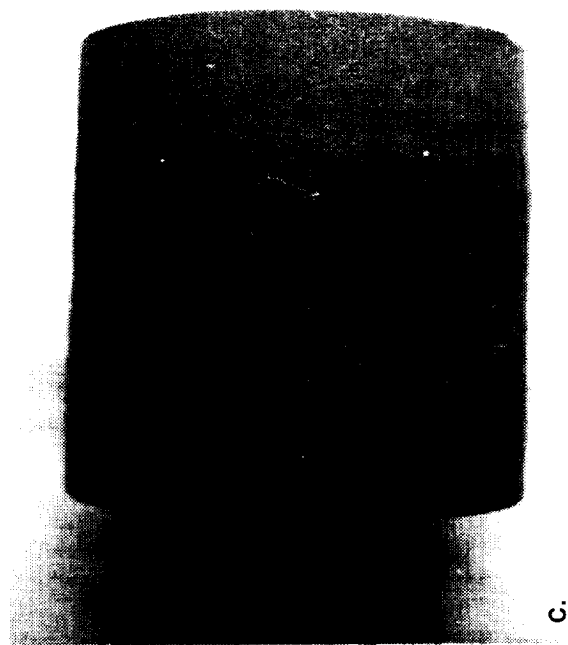
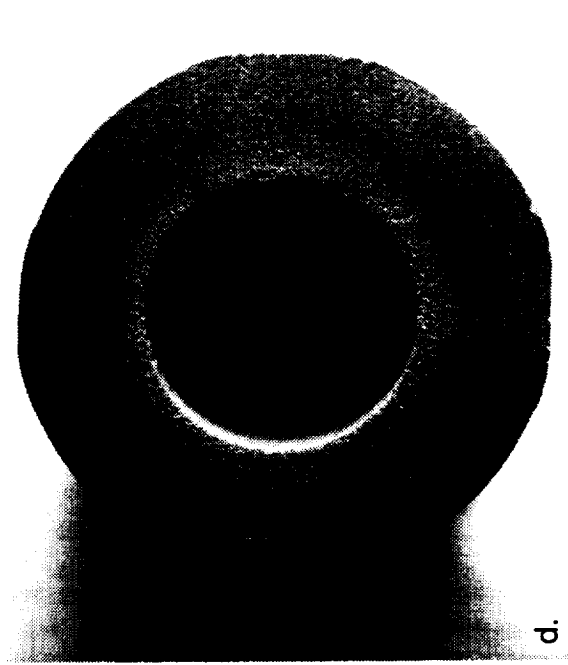
Appendix B Fig 5 Macrophotos of electropolished (a,b) AFN25, (c,d) AFN26 after 63 hrs.
